Spec Rite Inspections

SUMMARY REPORT

Client: Sample Client
Inspection Address: 2222 Test Address, Quartz Hill, CA 93536
Inspection Date: 7/11/2013 Start: 9:00 am End: 11:30 am
Inspected by: Tim Spargo, CMI

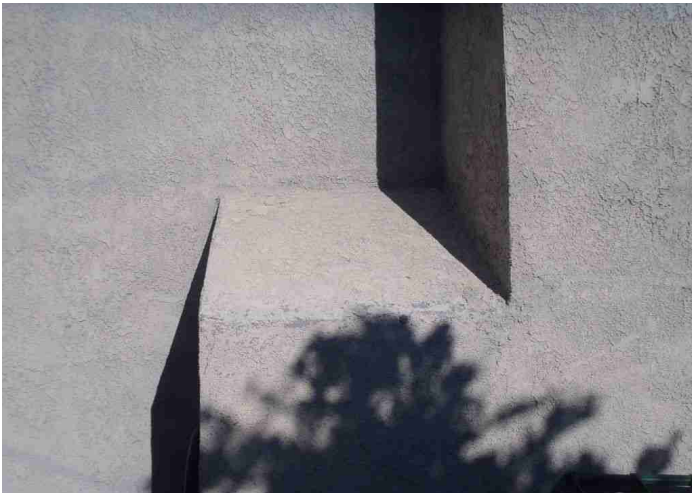
2.8 - As a recommendation you may wish to use a water proofing type paint on the horizontal portion of stucco, outside of the fireplace.

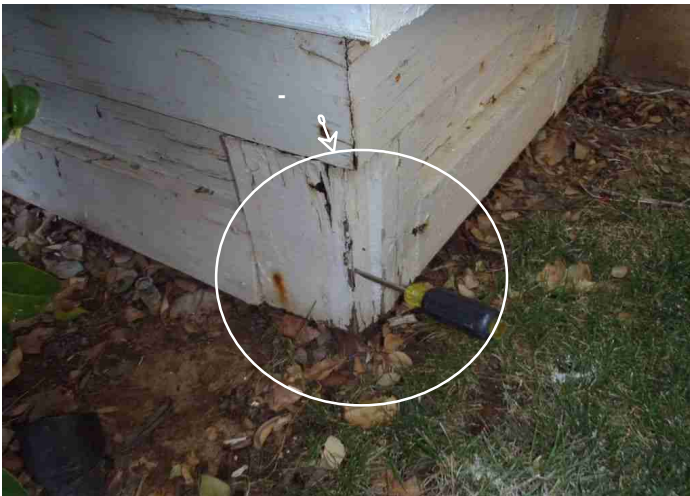
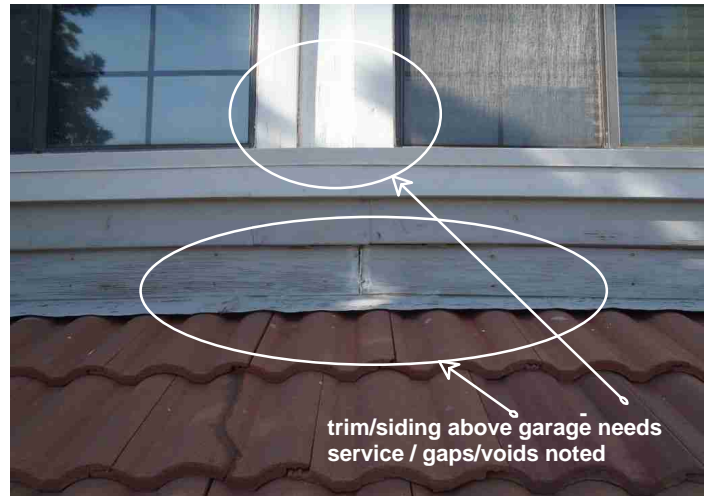
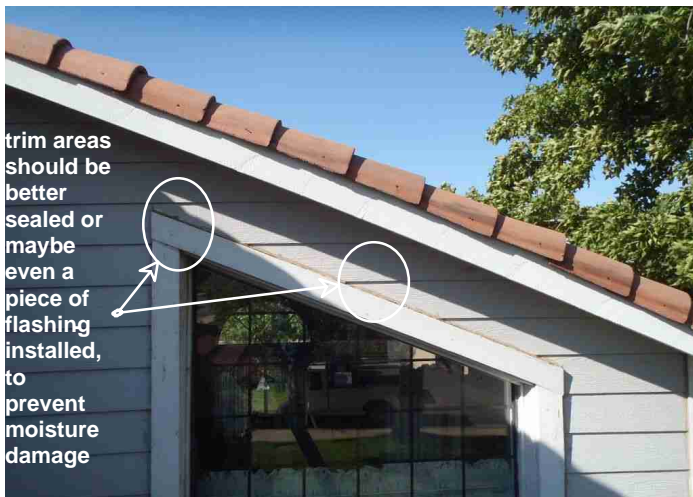
Noted trim and siding at front/right corner of the home is weather damaged and visibly rotted. Replacement of siding/trim in these areas is needed. Also noted in interior other section, active moisture intrusion has taken place to interior area opposite this corner of the home.

2.9 - Portions of the wood siding are weather damaged and need repairs such as replacement of damaged siding areas, paint and caulking to prevent further damage

Wood trim/siding areas above garage need service as well, such as paint/prime and sealing open joints etc.

Repairs by qualified contractor are needed to ensure further moisture intrusion is not occurring.

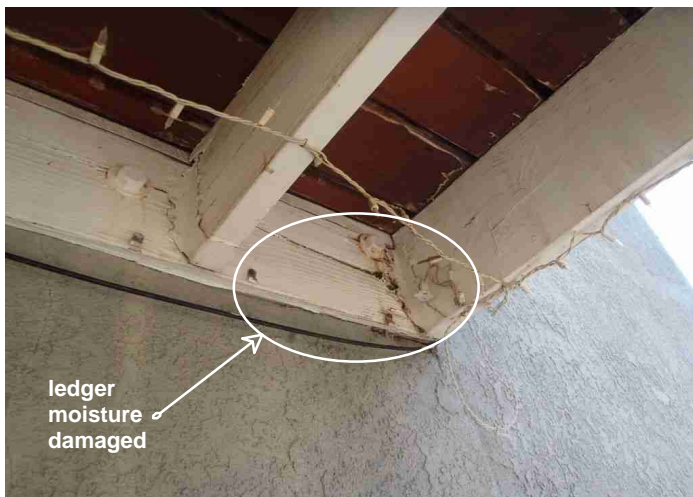
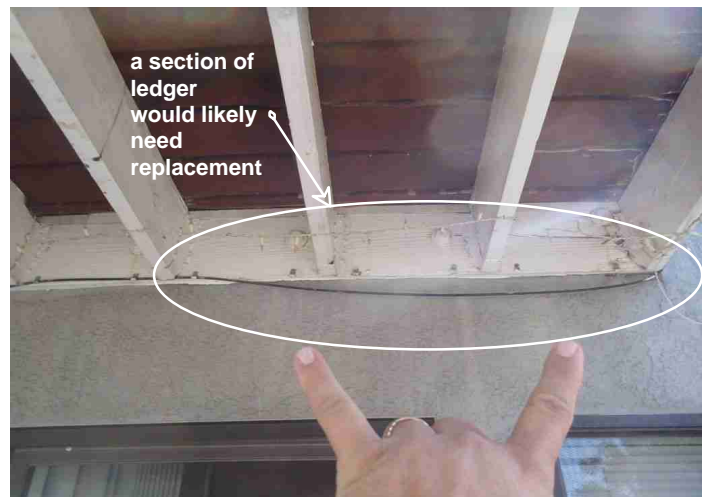
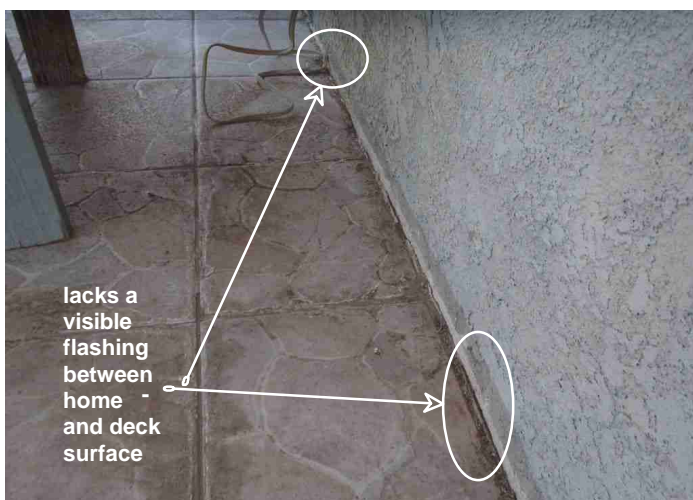
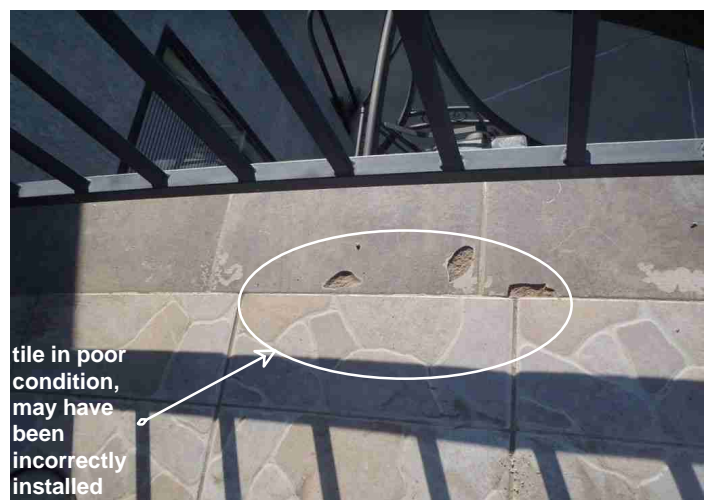
- The ledger is moisture damaged and a portion of such should be repaired for reasons of safety. The ledger is an important part of how the deck is attached to the home, failure to repair leaves the deck in a somewhat compromised condition. Also noted, the outer joist (west facing) may be in need of replacement as well.

- The deck lacks a visible flashing to seal the deck and wall, why there *may* be a flashing below tile, there should be a flashing above tile as well, to prevent moisture from further damaged structural components.

- The tile surface installed on the deck is in poor condition and may lack a moisture barrier and/or mortar bed under the tiles (meaning the tiles may have been directly attached to plywood or similar). Noted that the sheathing/plywood visible from the under side of the deck/tile is in visibly poor condition. I would recommend that a contractor familiar with deck and tile construction apprise you of repair/replacement costs.

The above repairs are recommended for reasons of ensuring the deck remains safe to use and to prevent further degrade.

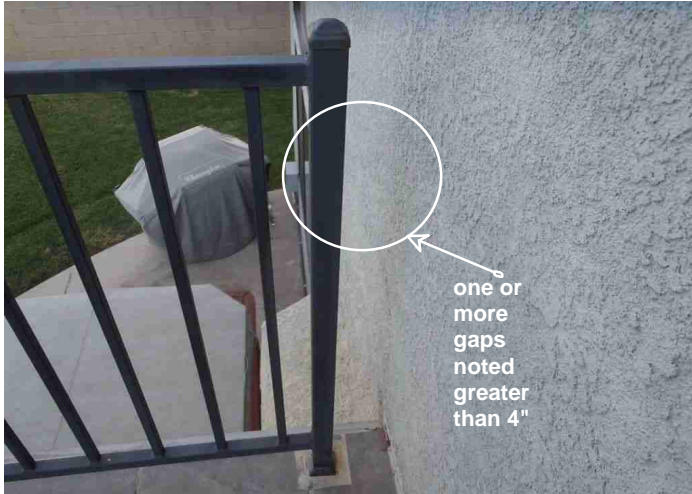
2.22 - The guardrail does not conform to common safety standards. Common safety standards require them to be a minimum of forty-two inches high when the standing surface is thirty inches or more above grade. Also, guardrail pickets should be no more than four inches apart for child safety.

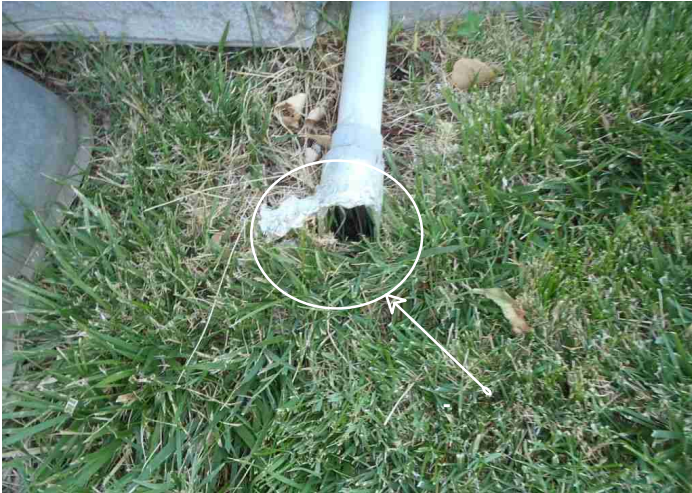
2.27 - The conduit fitting that serves the Portable Spa has a missing or damaged cover which needs replacement, as wires are exposed at grade level.

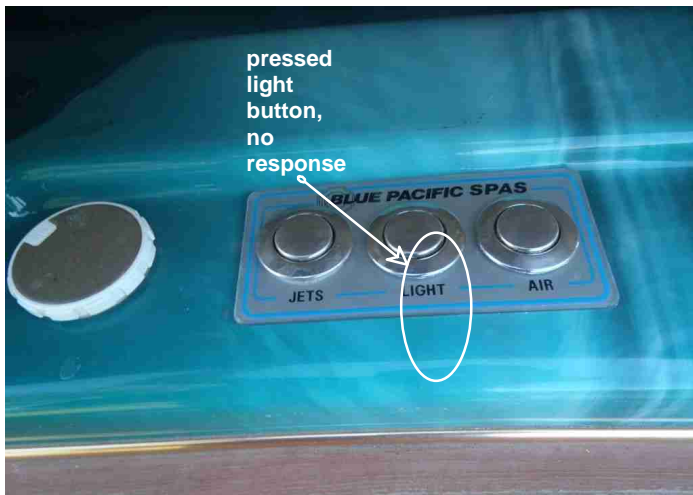
2.30 - Although portable spas are not generally part of the inspection report, I operated the pump/spa, but was not able to get the light working in the spa, you may wish to have the sellers demonstrate as operational or have serviced.

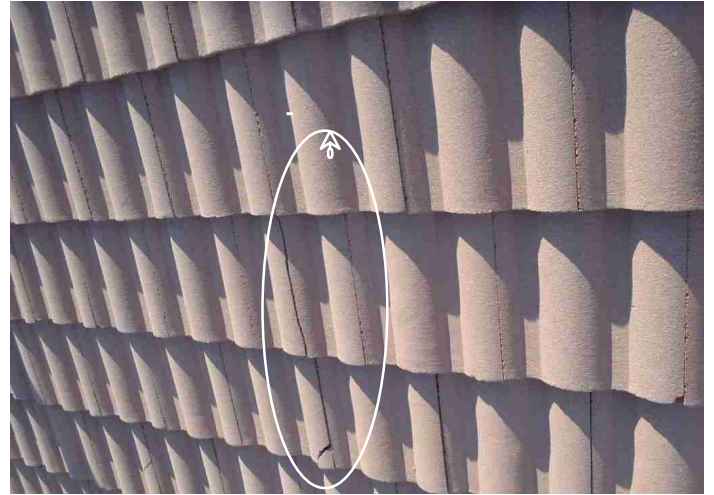
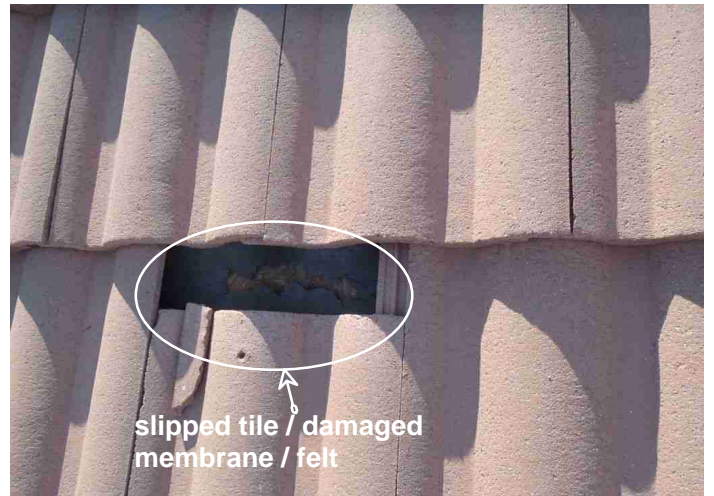
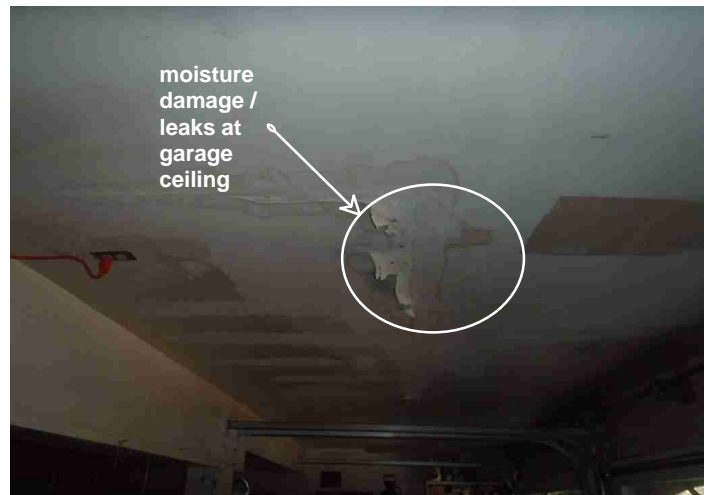
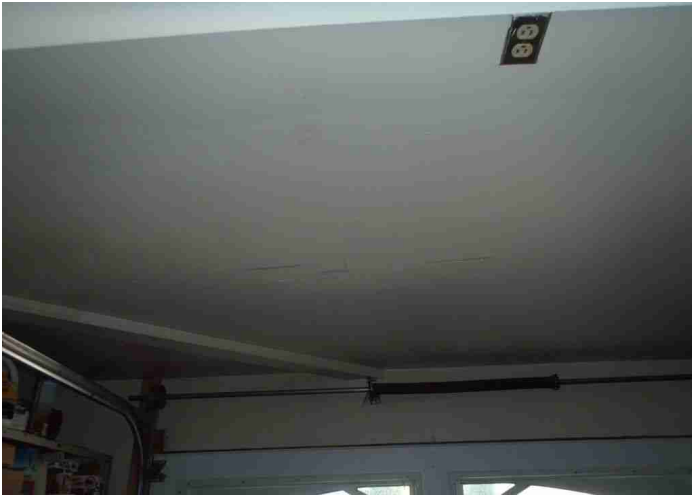
- Noted various broken tiles on the field of the roof above the home and a few above the entry/garage as well. A roofing contractor is recommended to repair/replace these broken tiles as needed.

- At least one broken tile has damaged moisture barrier/felt underneath it (second story of roof / east half) and a roofing contractor will need to repair this eventual leak-prone area.

The roof will need to be serviced for the reasons indicated within the report - *Continued*

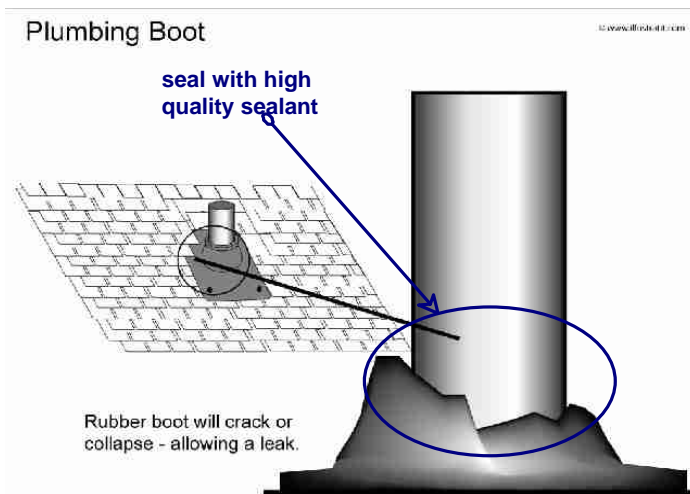
3.5 - Roof penetrations such as plumbing and heat vents need service to prevent leaks. There are gaps present where plumbing and heat vents meet their flashing or boots and need repairs such as sealing where these areas meet. This is important as these areas are common sources of leaks.

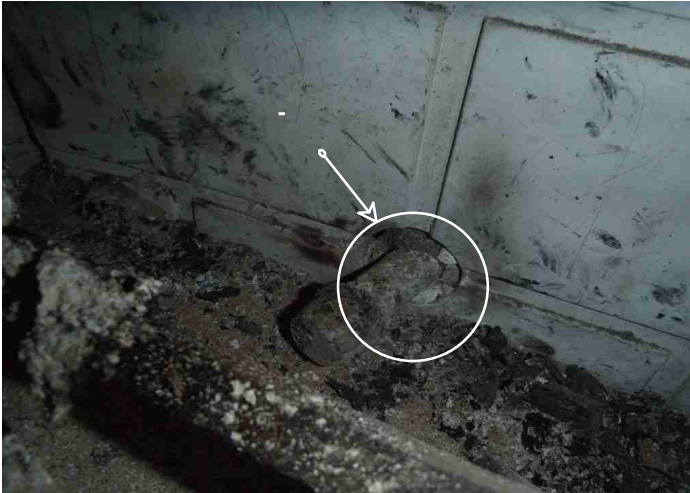
4.6 - The void around the gas pipe in the sidewall of the fireplace should be sealed with refractory caulk to prevent any possibility of back-drafting a flame beyond the combustion chamber, where it could come into contact with combustible material.

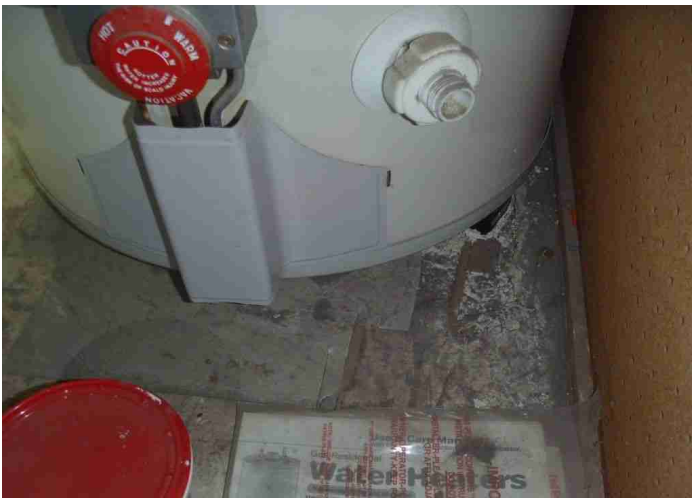
5.10 - The water heater is not installed over a drain pan and a leak could result in water damage. These items are not required but recommended.

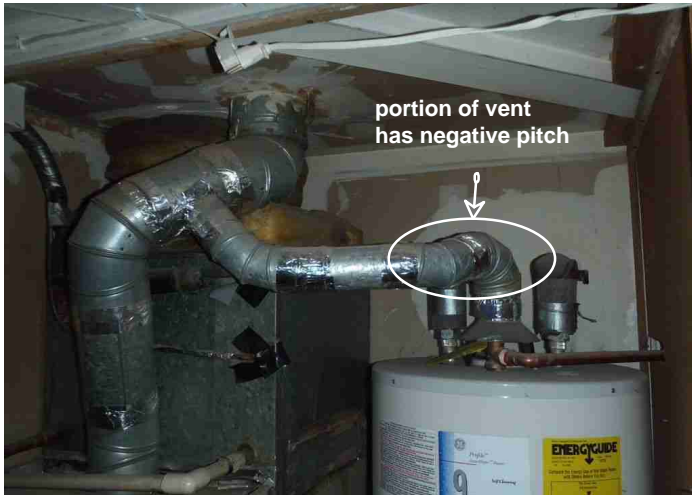
5.13 - The vent pipe is negatively pitched. To ensure a positive draft, it should rise at one-quarter inch per foot, and should be serviced.

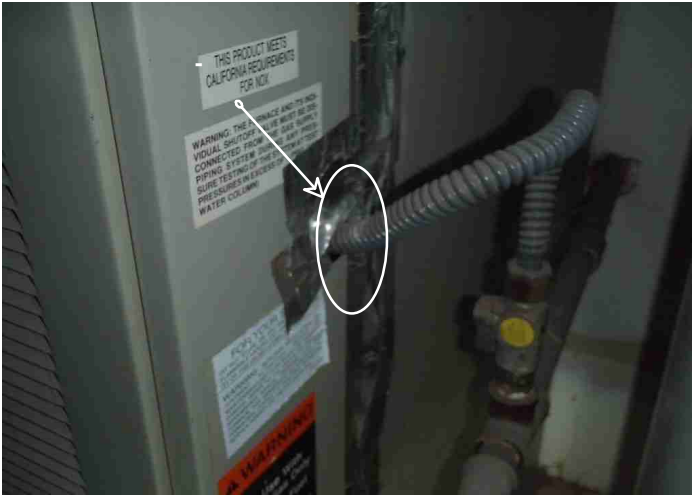
The gas feed line that passes through the furnace sidewall is flexible and should be rigid - *Continued*

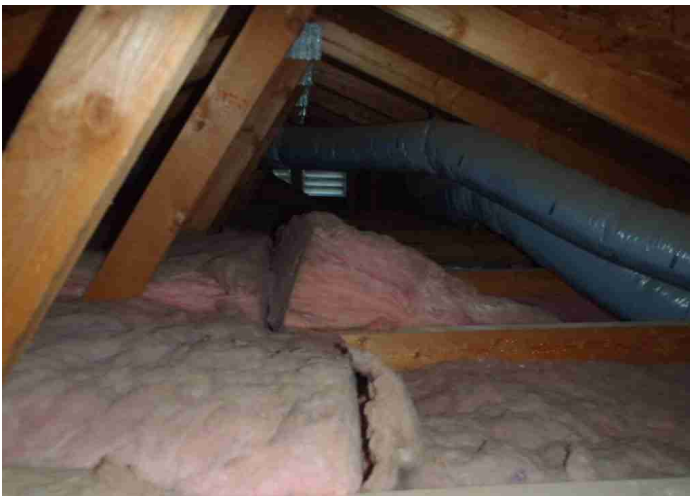
8.18 - The ducts are a modern flexible type that are comprised of an outer plastic sleeve and a clear inner liner that contains fiberglass insulation. However, the outer sleeve has been found to be susceptible to ultra-violet contamination, which causes the outer sleeve to deteriorate and, therefore, should be monitored.

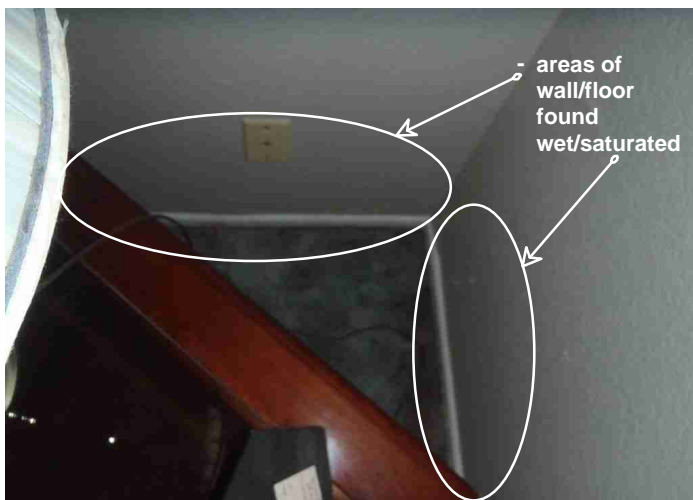
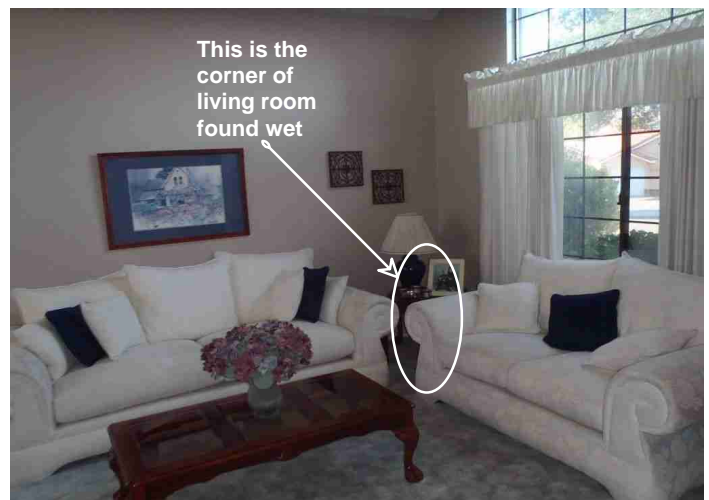
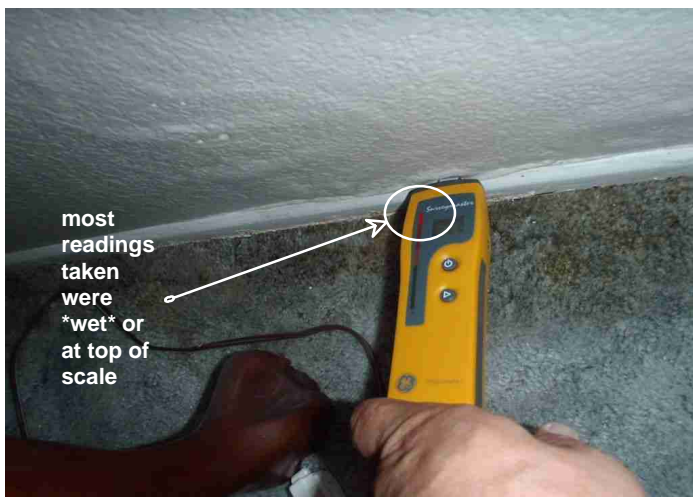
9.7 - Walls in corner of Living Room are wet and repairs are needed by contractor familiar with water damage or similar. Confirmed areas of active/wet walls and floors with specialty moisture meter. Area affected appears to be at least 18-24" to left/right of corner and drywall was found wet about 6-8" above the floor in this area. It is common to remove and replace affected drywall, but you should consult with a remediation contractor to ensure fungal or other conditions are not produced.

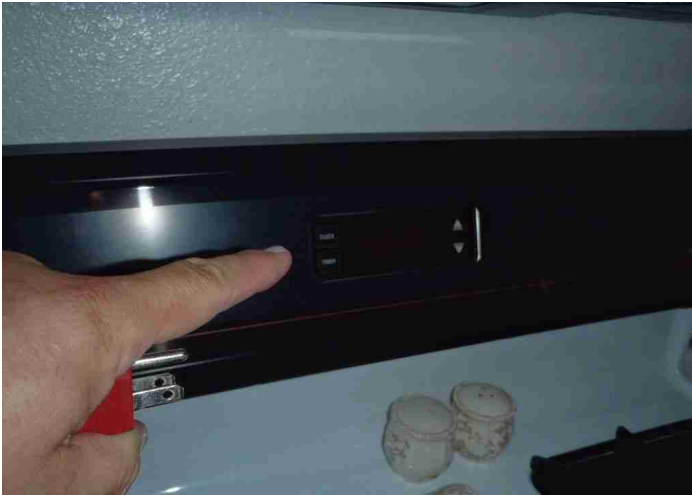
Clock or electronic display did not appear to be operable - recommend to have demonstrated as operational - *Continued*

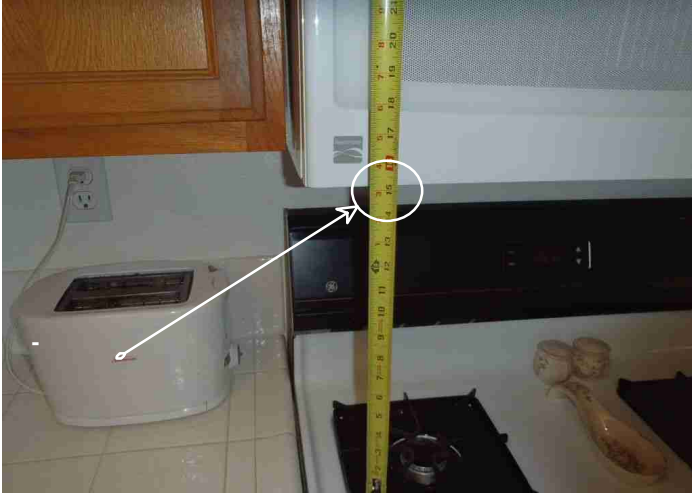
Clearance between microwave and gas Cooktop appears limited - *Continued*

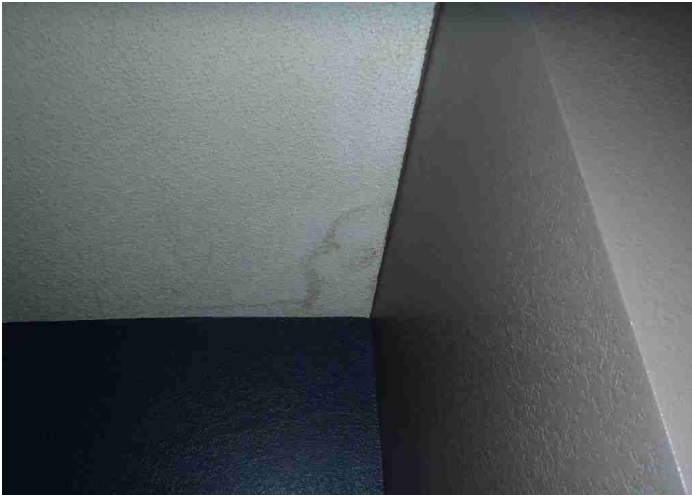
- Stain in corner of upstairs (east of two) bedroom ceiling of which, should be considered when roof is evaluated.

Stain noted on ceiling as noted in ROOF section of report - *Continued*

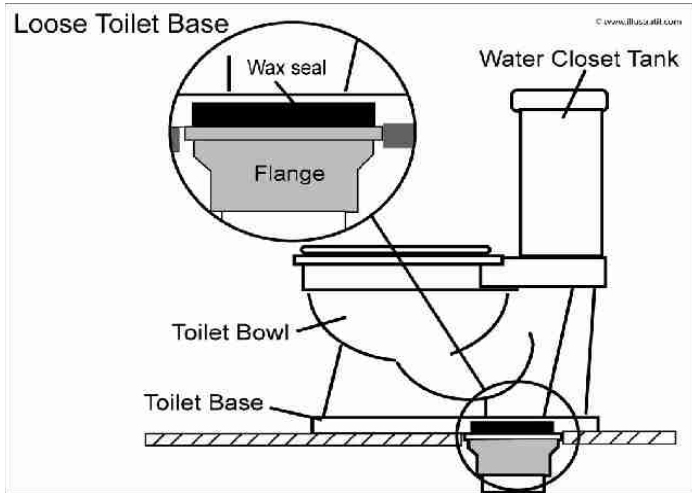
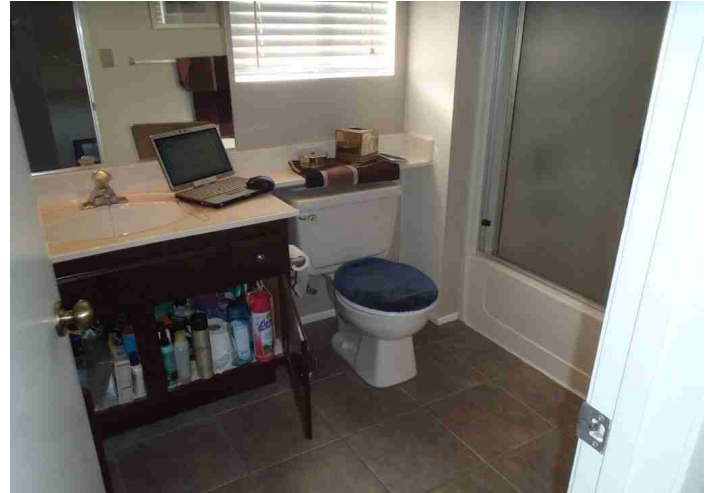
15.23 - The toilet is loose, and should be secured.

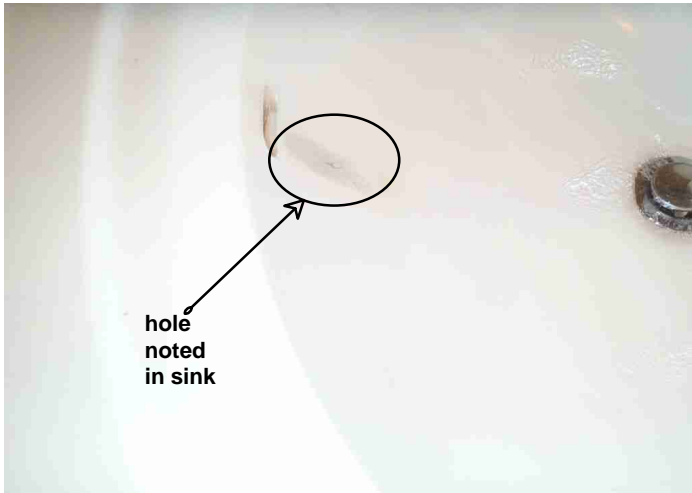
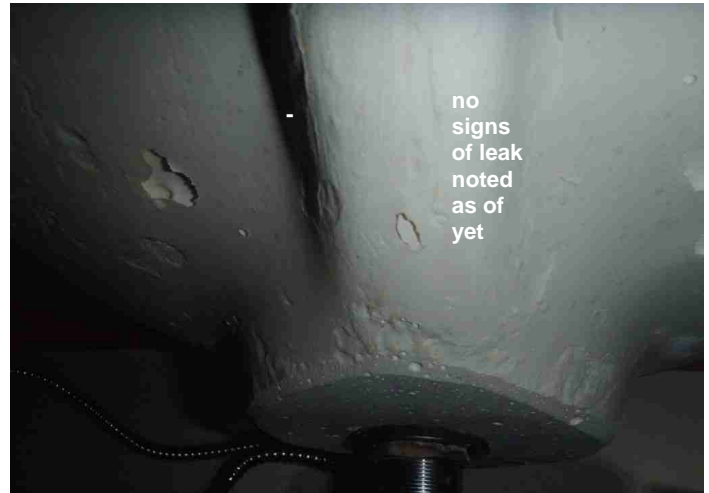
15.33 - Hole or similar degrade noted in the sink of the downstairs bathroom and while not yet leaking, you should be aware and may wish to obtain estimates for replacement to be aware of immediate and/or deferred costs.

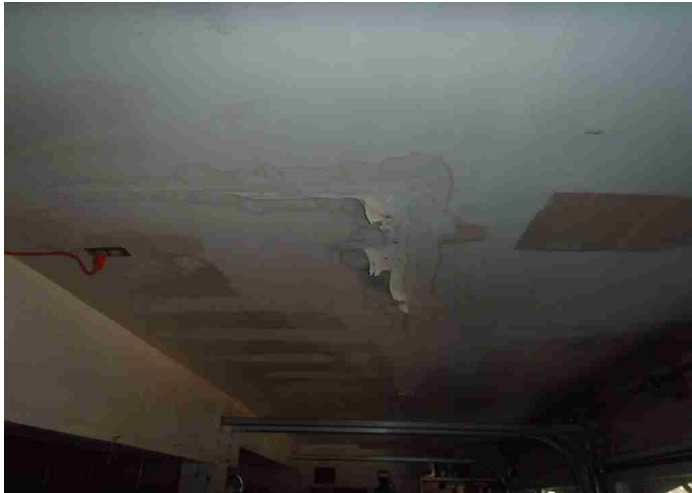
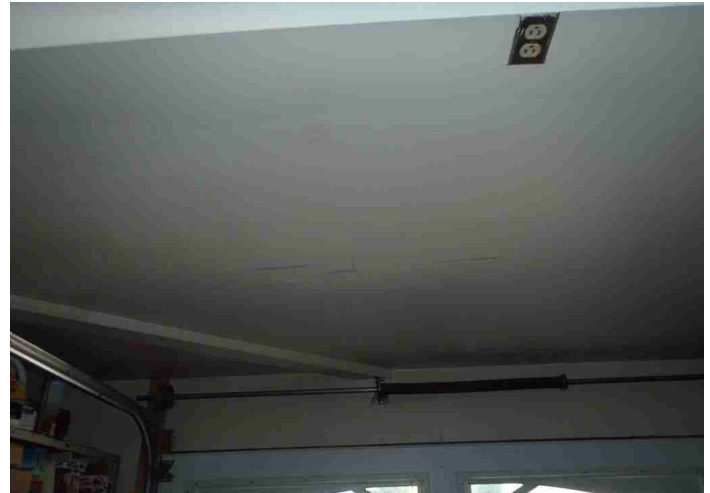
- Stains were noted in the ceiling of the garage, of which I recommend having a roofing contractor evaluate and determine source of stains as needed, as there may be a possibility of roofing/siding/trim areas above the garage ceiling in question.

17.2 - Moisture damaged drywall noted in garage ceiling that you may wish to have repaired, along the cause of such confirmed as noted in ROOF section.

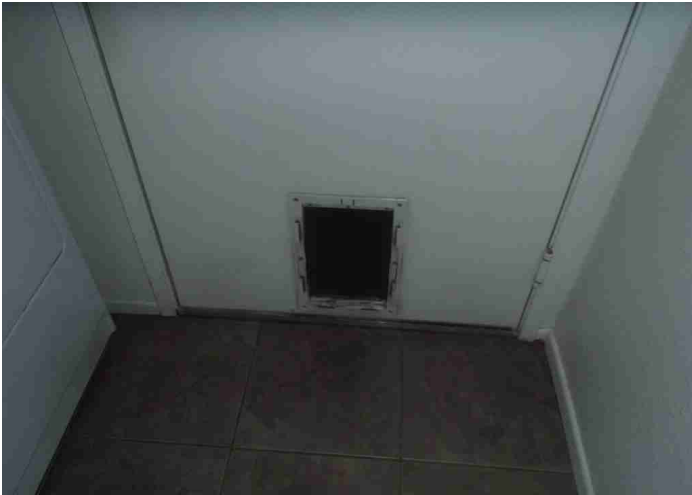
17.2 - The fire-rating of the house entry door has been nullified by the addition of an animal door. In general, replacement of the door becomes necessary to keep intact the fire door's rating, once alterations have been made.

The fire-rating of the house entry door has been nullified by the addition of an animal door - *Continued*

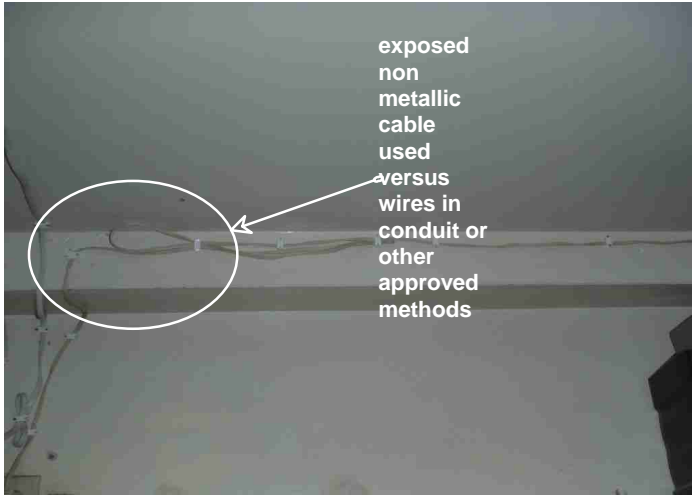
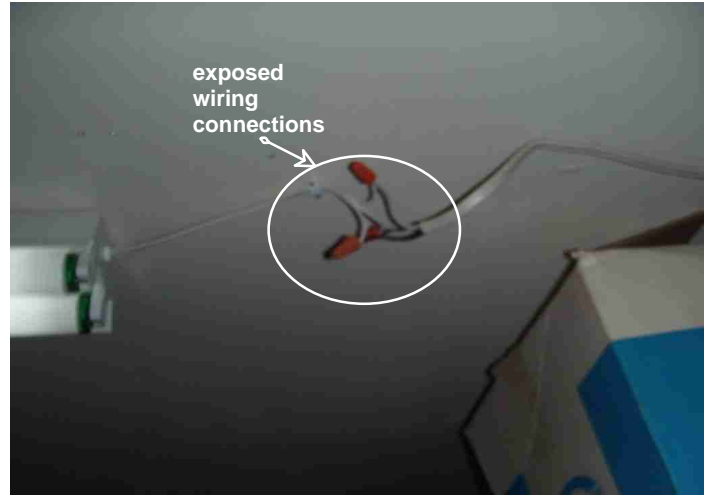
17.10 - Exposed non metallic cable and exposed wiring connections used for the shop lights in the garage, I recommend an electrician use permanent wiring methods and properly conceal connections for obvious safety reasons.

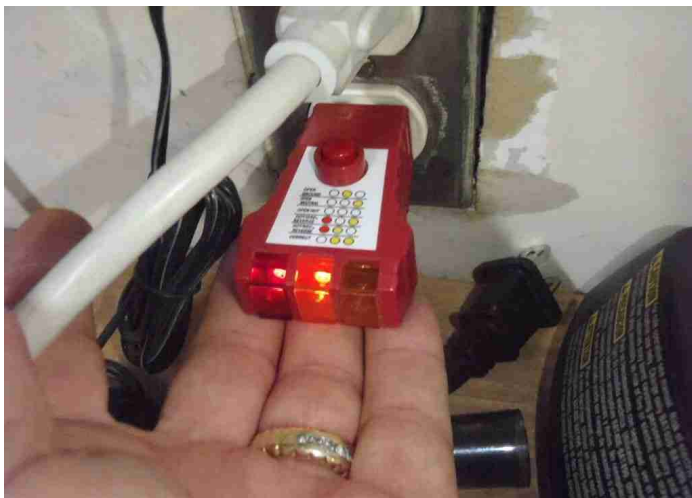
17.11 - An outlet has reversed polarity, but should be serviced. Outlet was noted in front of parking area.

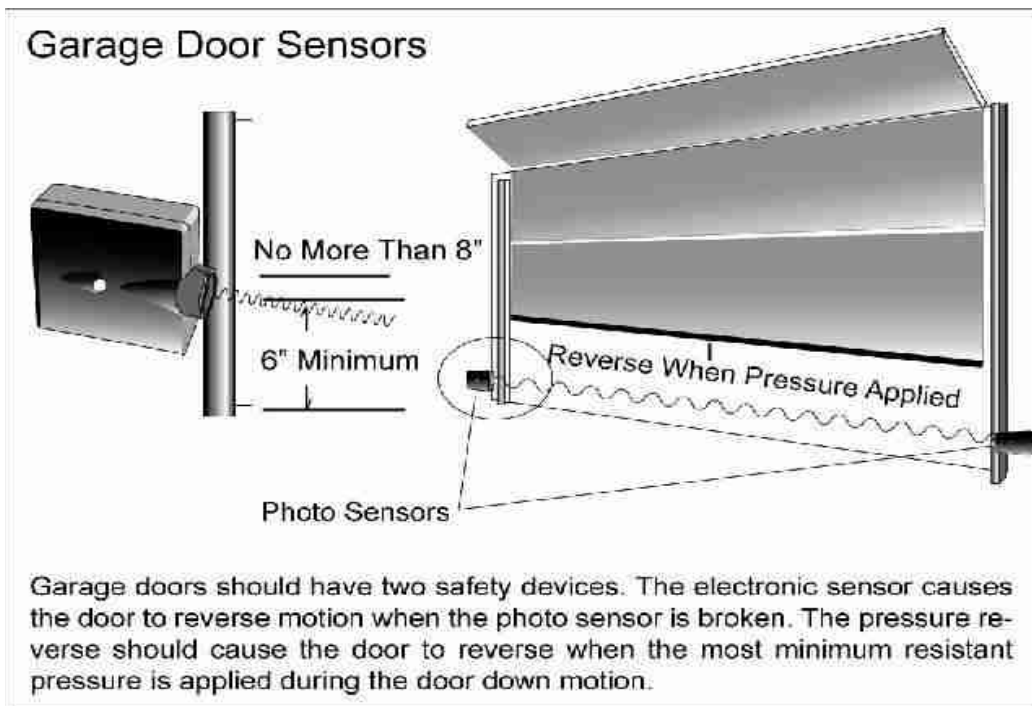
Illustration - 4 The opener is not equipped with infra-red sensors that enable the door to auto-reverse
