Spec Rite Inspections

SUMMARY REPORT

Client: Sample Client
Inspection Address: 2222 Test Address, Quartz Hill, CA 93536
Inspection Date: 7/11/2013 Start: 9:00 am End: 11:30 am
Inspected by: Tim Spargo, CMI

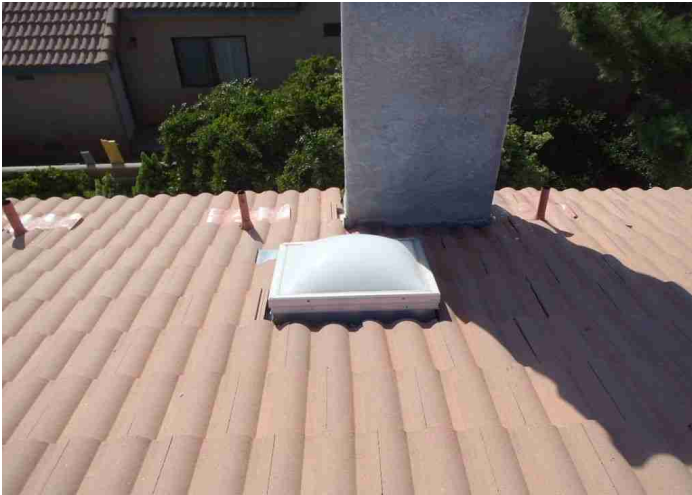
3.6 - The roof includes one or more skylights, which are notoriously problematic and a common point of leaks. There are different methods of installing them and, although opinions will vary, some methods are better than others. Therefore, it will be important to keep the area around them clean and to monitor them for evidence of leaks.

The roof includes one or more skylights that need to be monitored - *Continued*

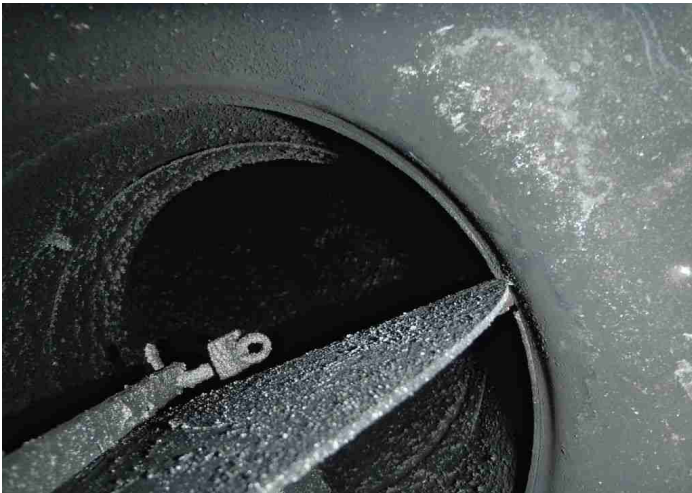
4.3 - The portions of the flue that are visible appear to be in acceptable condition.

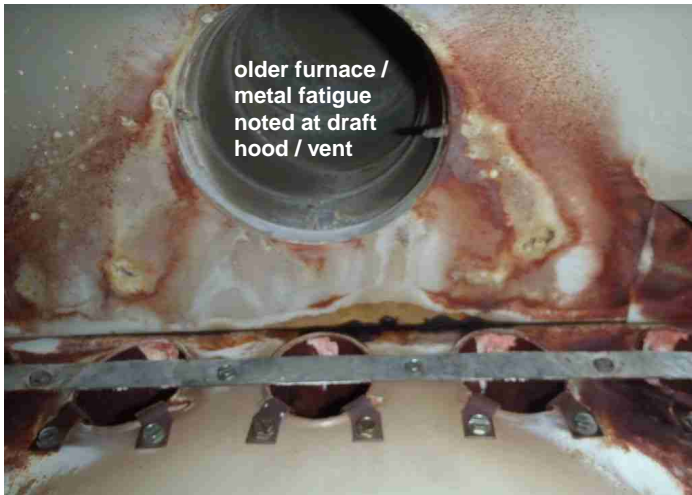
Split system is functional but nearing end of service life - *Continued*

As equipment near's the end of it's service life, replacement of the equipment would likely be recommended by many if not most HVAC contractors based on the system's efficiency and age. If it is not affordable for you to replace this equipment, you should have it annually inspected by a HVAC contractor that services your area, to simply ensure that the system is safe and reliable.

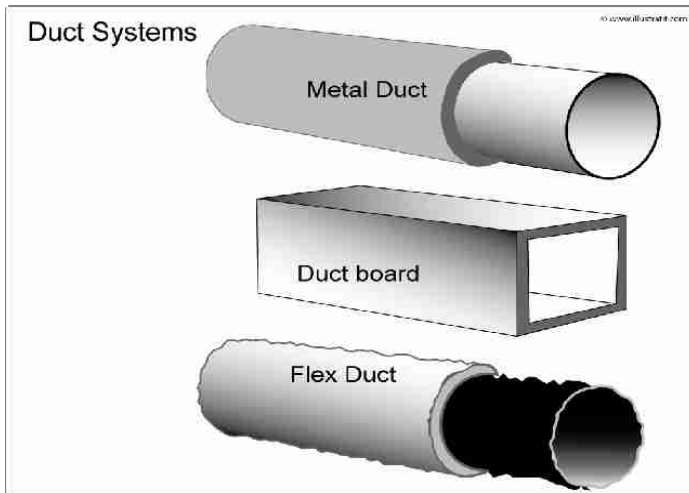
8.17 - The ducts have no visible deficiencies. They are a modern flexible type that are comprised of an outer plastic sleeve and a clear inner liner that contains fiberglass insulation. We inspect the visible portions of the flexible ducting, as it is common in attics that not all portions of the ductwork is viewable.

The flexible ducts have no visible deficiencies - *Continued*

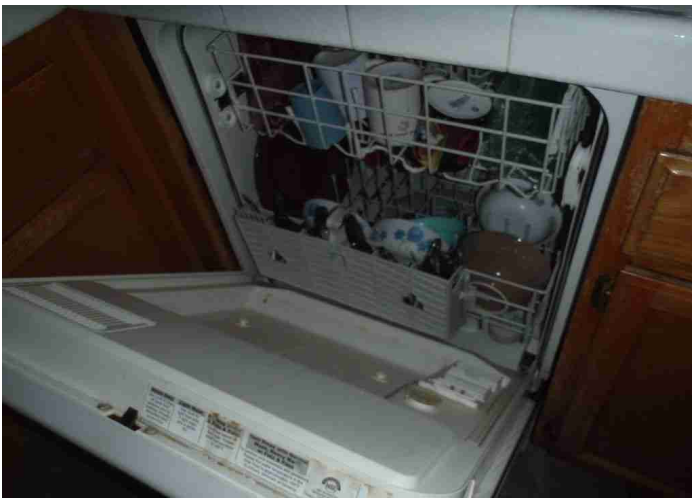
10.11 - Dishwasher not operated as occupants items are present. Have sellers demonstrate the unit is operational.

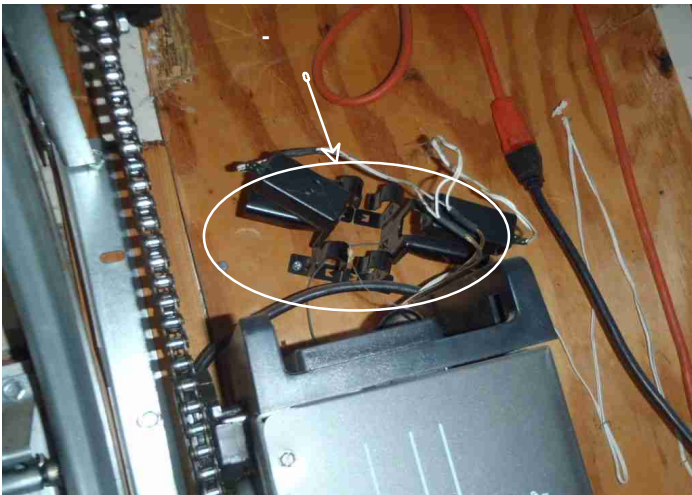
17.7 - The opener for the main door is not properly equipped with infra-red sensors that enable the door to auto-reverse, which is obviously a desirable safety feature. The sensors present have been situated in a way to have bypassed their protection. A qualified overhead/garage door contractor should service.

17.8 - The garage door opener is functional, but it does not auto-reverse or may need to be adjusted, which is part of an opener's safety function and is important to have serviced.
